ERDC/CERL TR-03-5

Overcoating of Lead-Based Paint on Steel Structures

Cost and Performance Report

March 2003

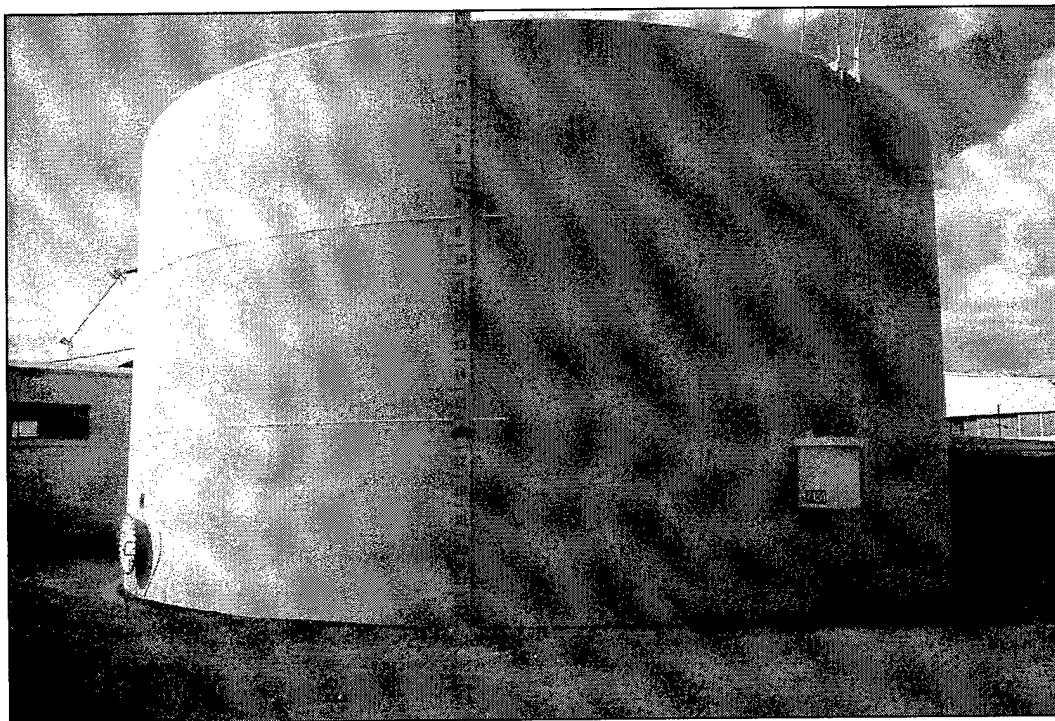
Figure 4. Deluge tank at Fort Campbell Army Airfield after overcoating completed in August 2001.

After evaluation of the two coating systems, the coating system composed of Sherwin-Williams Corothane I Mastic primer, Corothane I Ironox A intermediate, and Corothane I Ironox A topcoat was chosen for completion of the tank coating job, as shown in Figure 4. The projected life of the overcoat repair on this tank is 15 to 25 years. This projection is based on the pre-overcoat condition of the original paint system, the durability of the overcoat materials, and the severity of the exposure environment. It should also be noted that the water tank can probably be overcoated two more times provided its condition is not allowed to deteriorate past that which is suitable for overcoating.
